Wetland monitoring for off-site wetland mitigation at the Olentangy River Wetland Research Park for Spring-Sandusky Interchange (Year 2 - 2002)

William J. Mitsch and Li Zhang

Olentangy River Wetland Research Park, The Ohio State University

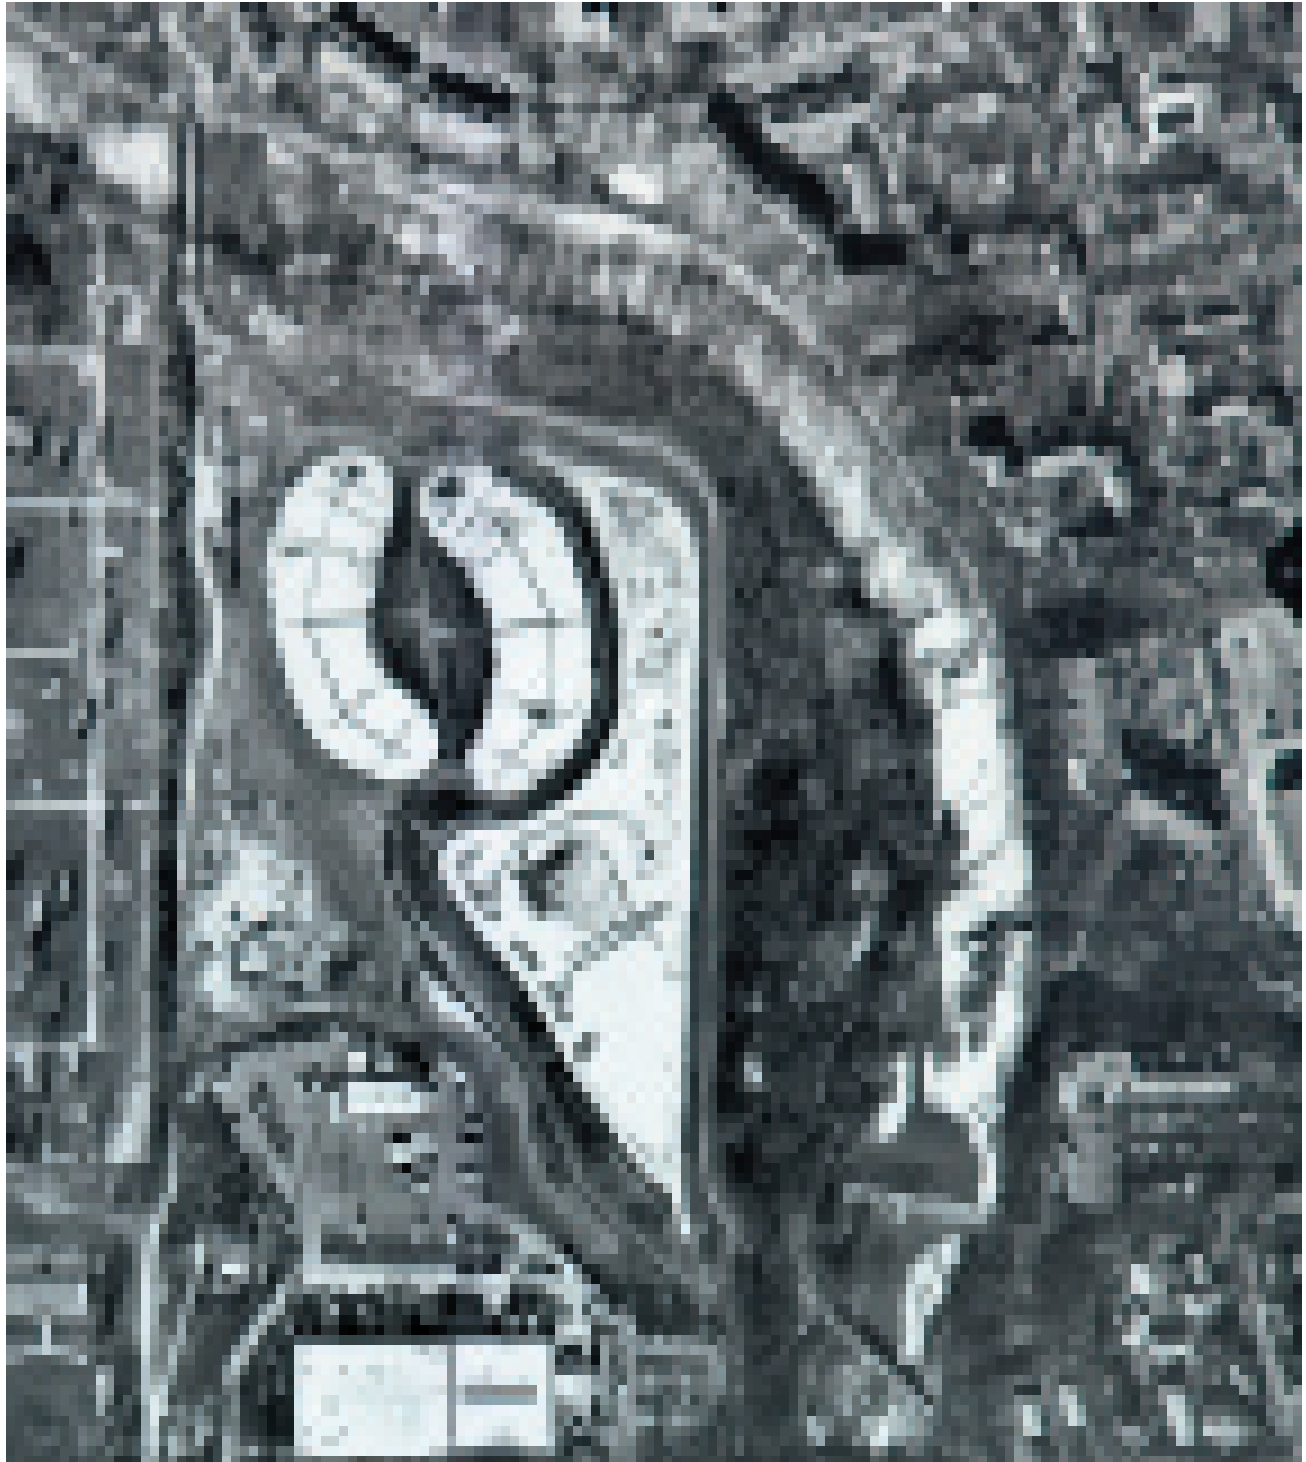
The winter photograph of January 4, 2002 (Fig. 3) illustrates the forest floor without canopy vegetation blocking the view. No scours or excessive destabilization of the floodplain is seen as a result of the flooding. The photo also illustrates considerable ponding, as expected, at the northern part of the bottomland hardwood forest and at internal channels in the southern third of the bottomland forest. This corresponds well with the contours measured

Figure 3. Aerial photo of entire site on January 4 2002, about 19 months after levees were cut and 3 months after initial honeysuckle harvesting.

before the restoration began as shown in Fig. 2. Groundcover is also seen much more clearly in this photo in the northern third of the bottomland forest, possibly due to extensive honeysuckle removal in that part of the forest in 2001.

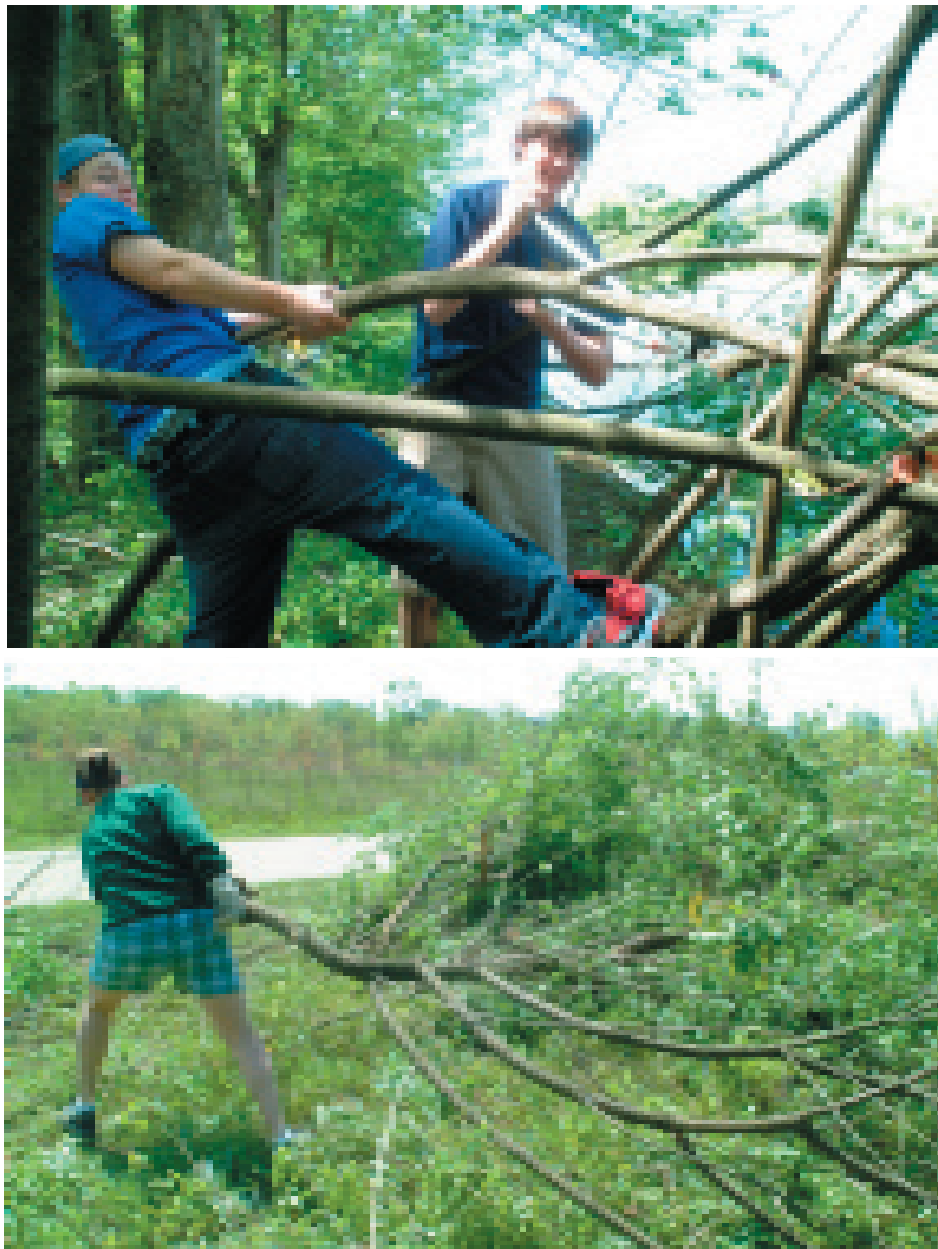
volunteers removed honeysuckle aboveground biomass as part of a restoration of portions of northwestern corner of the ORWRP bottomland forest on an event called “Wetland Day” on May 3, 2002 (Fig. 5). The city of Columbus applied herbicides on plant stumps (well away from volunteers) during this event. This event was cosponsored by Friends of Lower Olentangy Watershed (FLOW), Ohio Department of Transportation (ODOT), the City of Columbus, and the Olentangy River Wetland Research Park. A second honeysuckle harvest with about 30 OSU volunteers on September 24, 2002. All harvesting to date has occurred in the northern one-third of the bottomland hardwood forest, approximately to the curve in the river. It is estimated that about 4 acres of the bottomland forest have had a first or second honeysuckle harvesting to date.

Figure 5. Photos taken on May 3, 2002, showing removal of alien honeysuckle plant material from bottomland hardwood forest by Ohio State University volunteers during ORWRP “Wetland Day.”

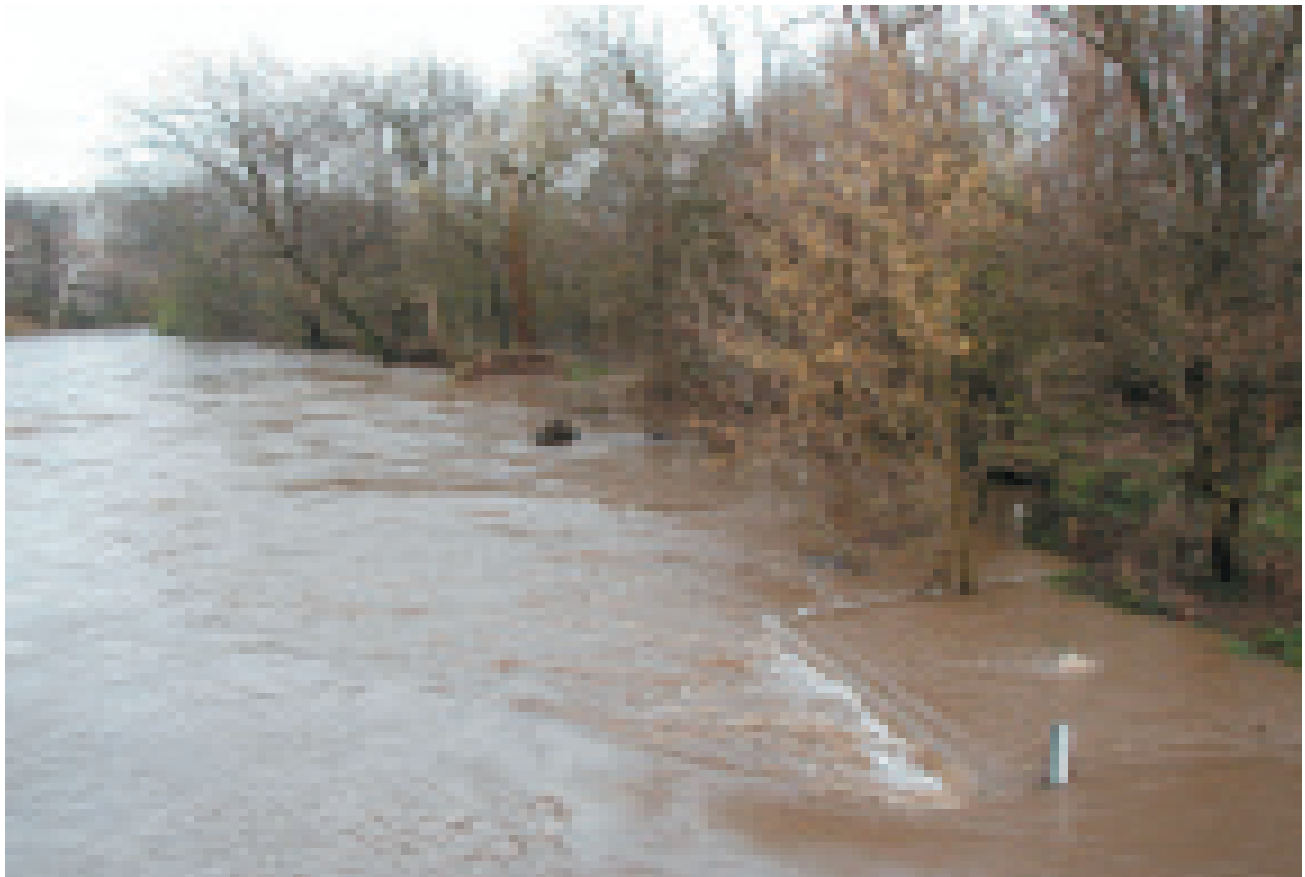
Figures 8 and 9 shows photos from one of the large flooding event to occur on the Olentangy River since 1995: April 14, 2002.

Figure 8. Olentangy River flood of April 14, 2002 flood as viewed from northern bikepath bridge. Bottomland forest is on right during flooding. Note river staff gage almost completely submerged in lower right of photo.

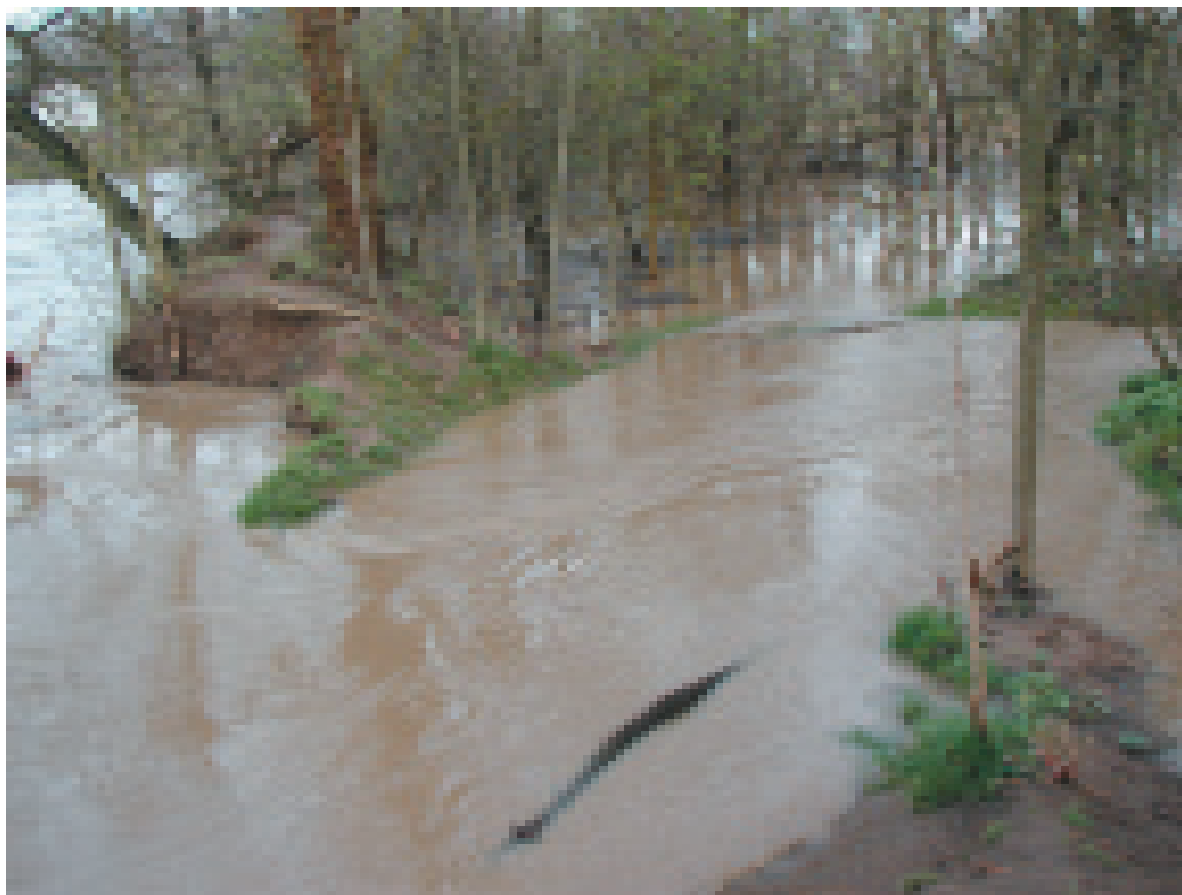
Figure 9. Flooding event in April 14, 2002. Top: cut #1 in the bottomland forest levee with water flowing from the river on left into the bottomland forest. Bottom: Interpretative sign and bikepath under water near Cut #1.
